PROPERTY INSPECTION REPORT

George Castillo HI11662
Professional Property Inspectors

Date of Inspection: 3/4/2026
Year Built: 1981/45 Yrs Size: 1825 ft.²
Weather: Clear

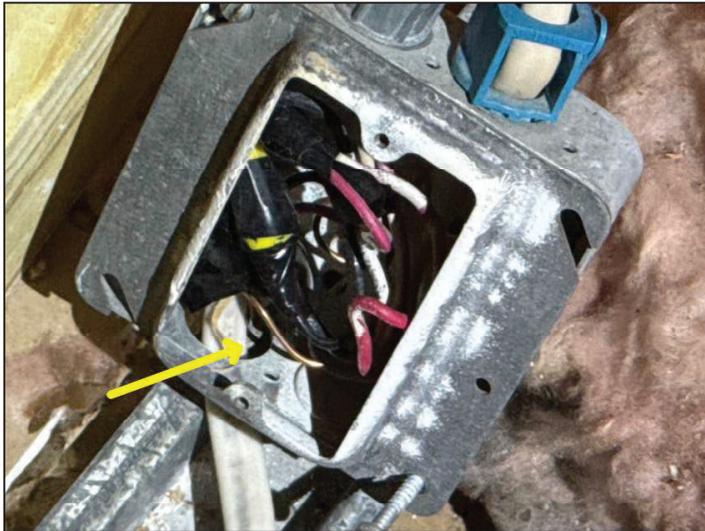
- Open junction boxes were observed, which is a safety concern. Recommend installing proper covers, as needed, for safety.

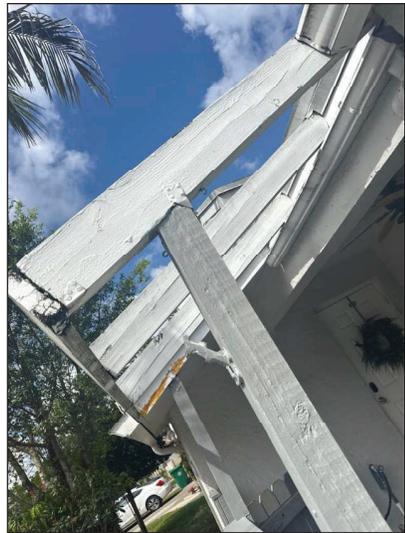
- Suggest sealing/caulking as part of routine maintenance.
- **Moisture damage, wood rot, observed. Recommend review of all areas for repair as necessary. Est cost \$700+**

Moisture damage

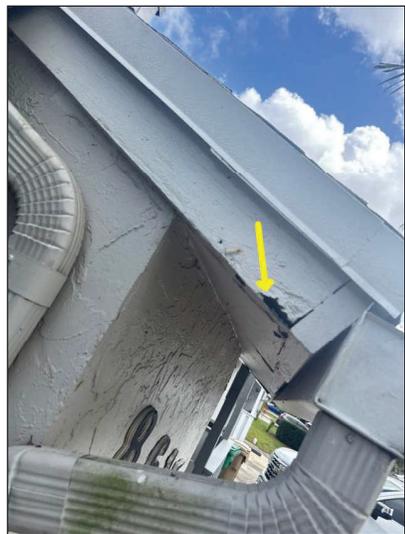
Wood rot noted

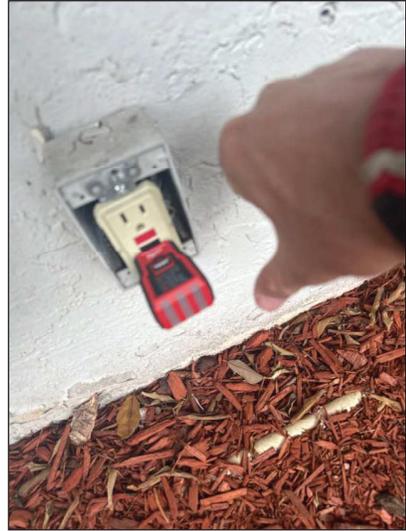
- Reverse polarity noted at outlet. Est cost to repair all electrical issues noted throughout the report to include changing exterior panel \$1,750+

Reverse polarity

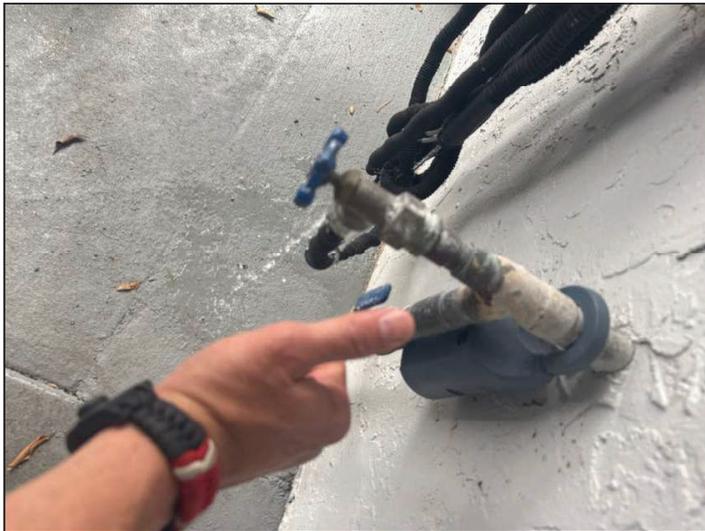
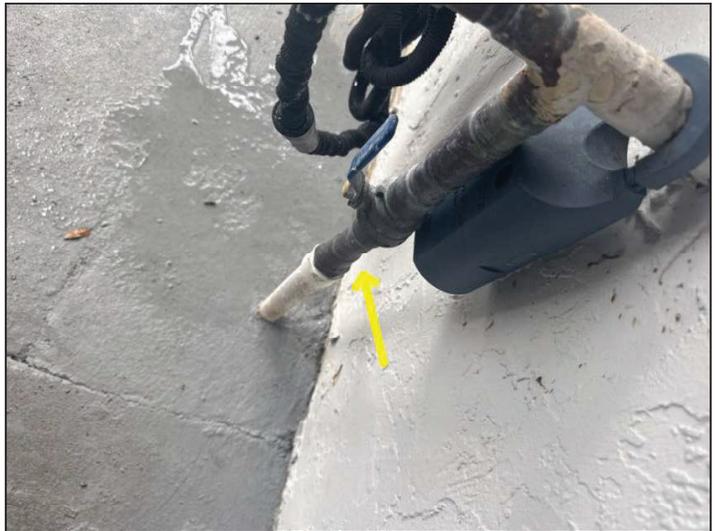
- Spigot on left side of home was not operational. Loose pipe noted. Have plumber evaluate and repair.

Loose not operational

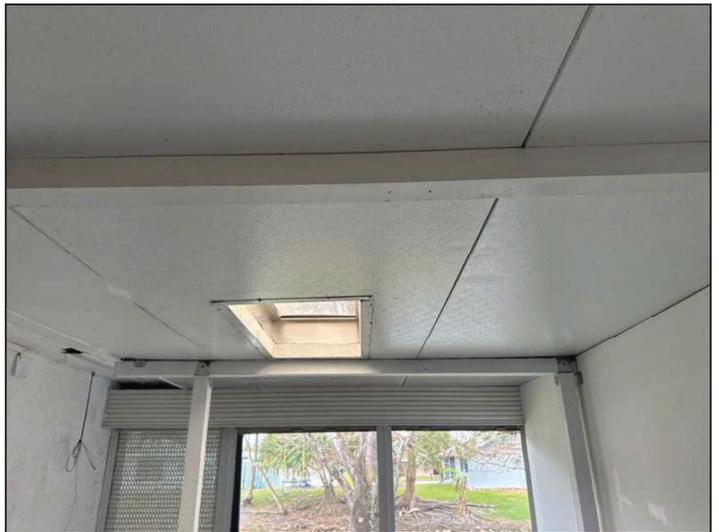
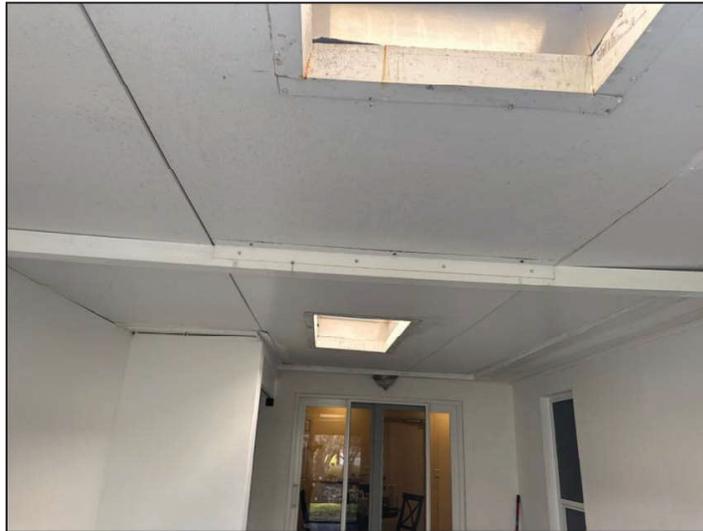
- Active leaking noted around skylights. Repairs will be needed to make this area waterproof. Buyers advised that HOA is not responsible for this section of the roof as it is not living area and considered outside patio.

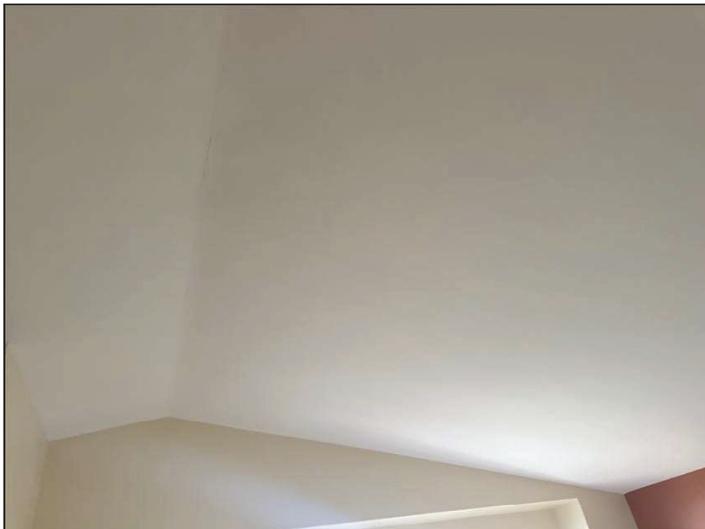
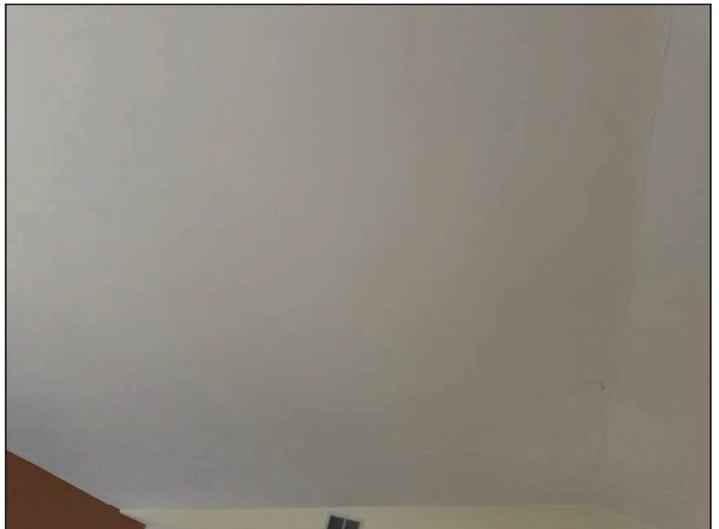
- Small cracking in the roof finish is noted. This is probably caused by the joint compound (spackle) drying too quickly during application.

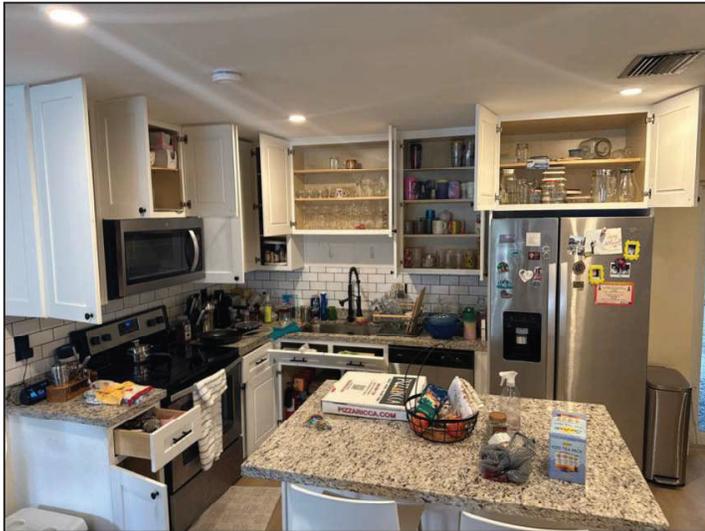
- Appeared functional and in satisfactory condition, For the age of the kitchen time of inspection. Common Cosmetic damages noted Note: doors needs adjusting as some rub together

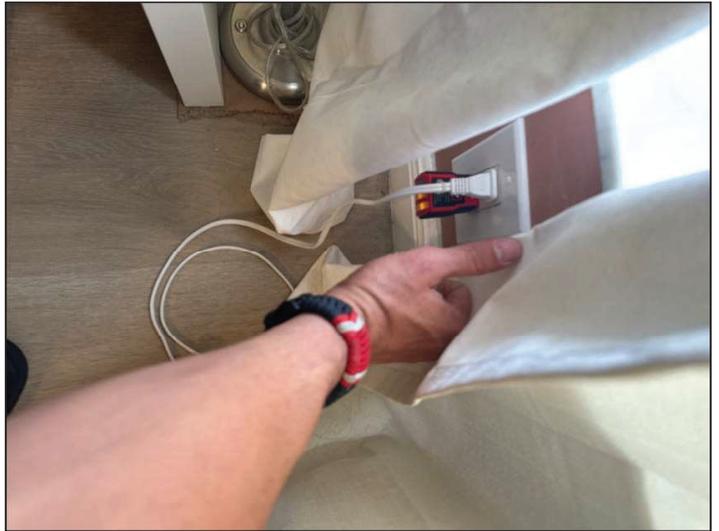
- Outlet to the right of exit door and to the right of bed have reverse polarity have Electrician evaluate and repair

Reverse polarity

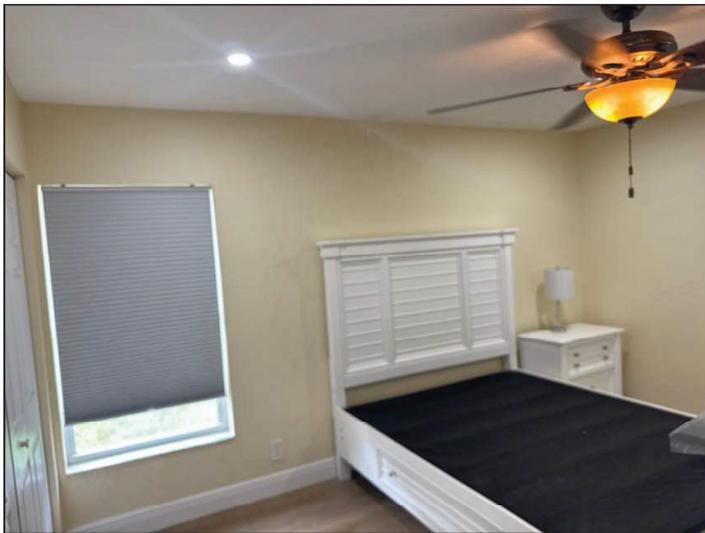
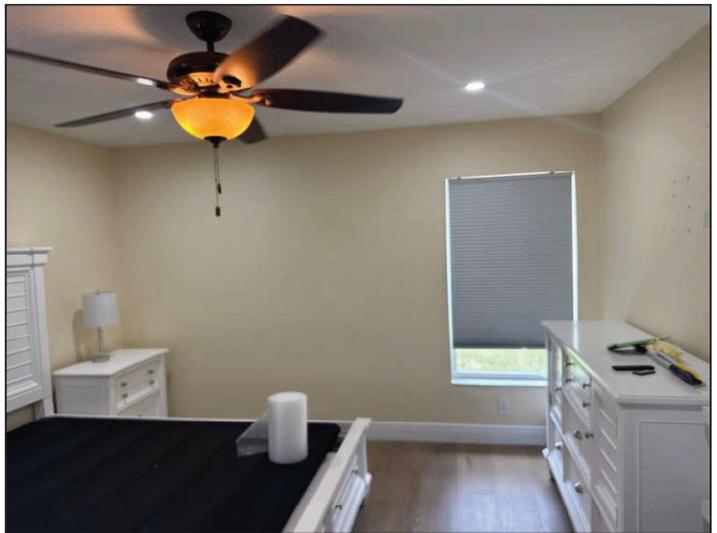
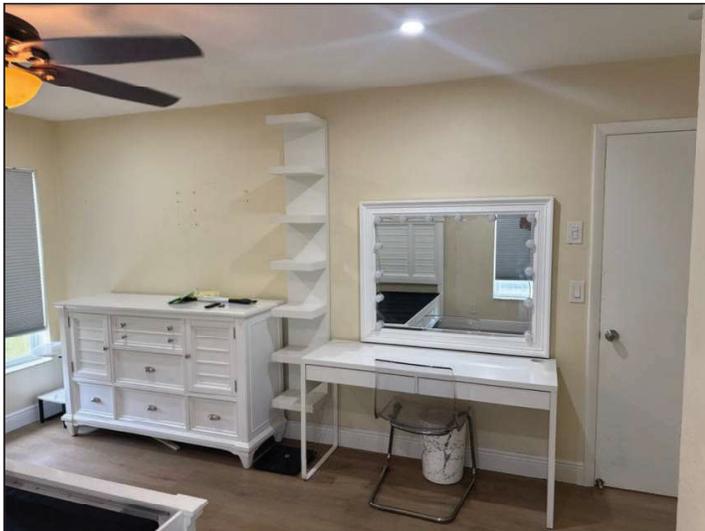
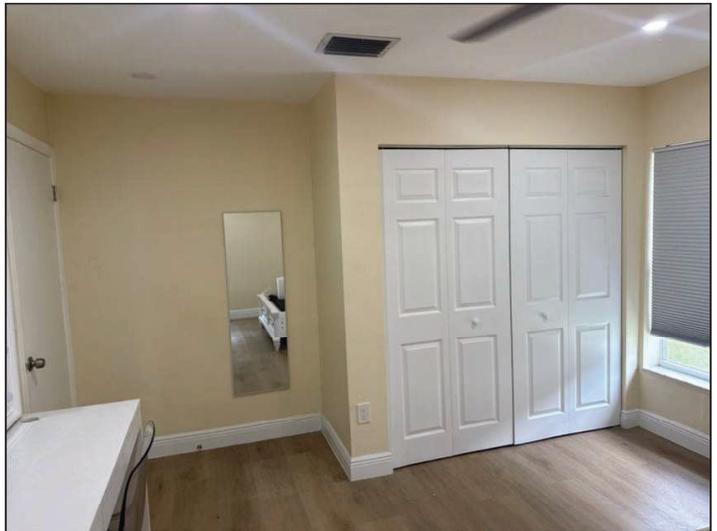
- Cosmetic issues noted underneath window area. Tested dry at time of inspection.

DRY

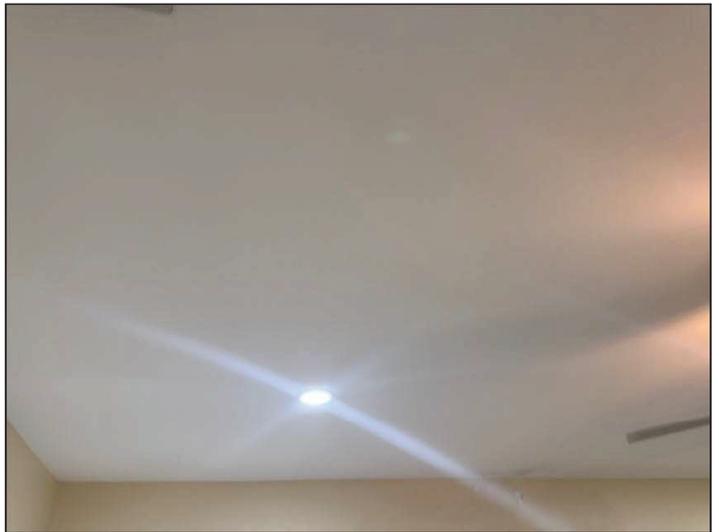
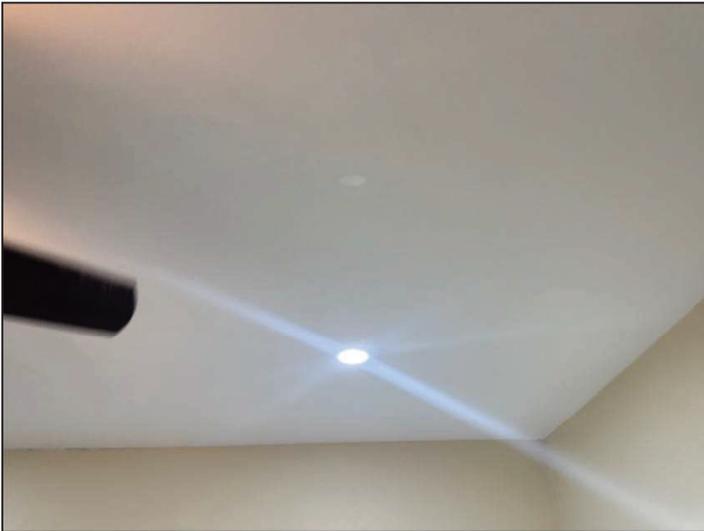
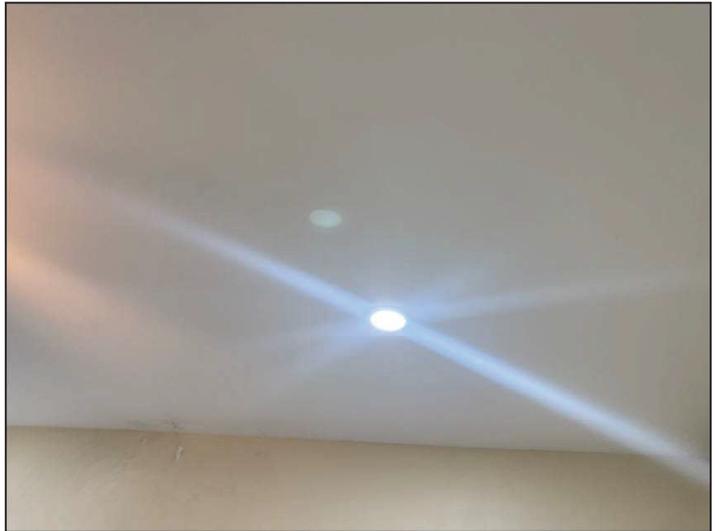
- Cosmetic issues noted at ceiling area. Tested dry at time of inspection.

DRY

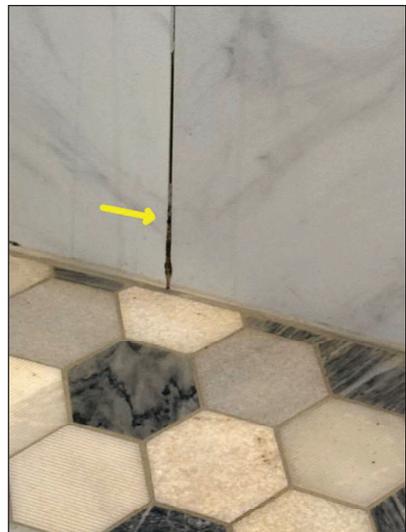
Observations:
• ****MATERIALS****
• Ceramic tile noted.
• ****OBSERVATIONS****
• Caulking needed around perimeter.
