PROPERTY INSPECTION REPORT

George Castillo HI11662
Professional Property Inspectors

Date of Inspection: 3/4/2026
Year Built: 1981/45 Yrs Size: 1825 ft.²
Weather: Clear

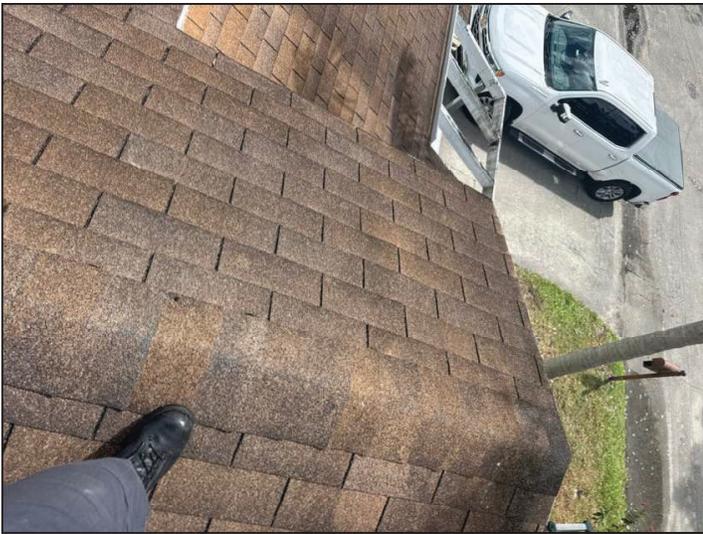
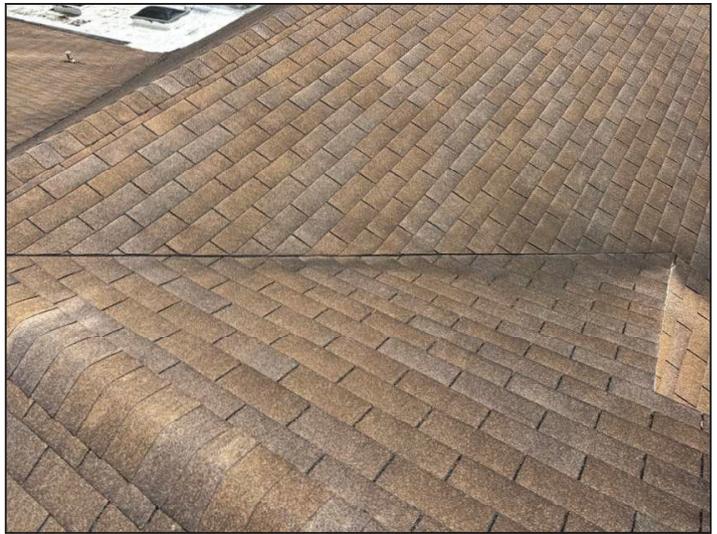
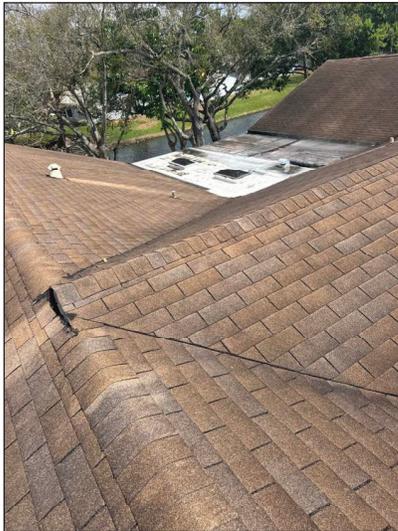
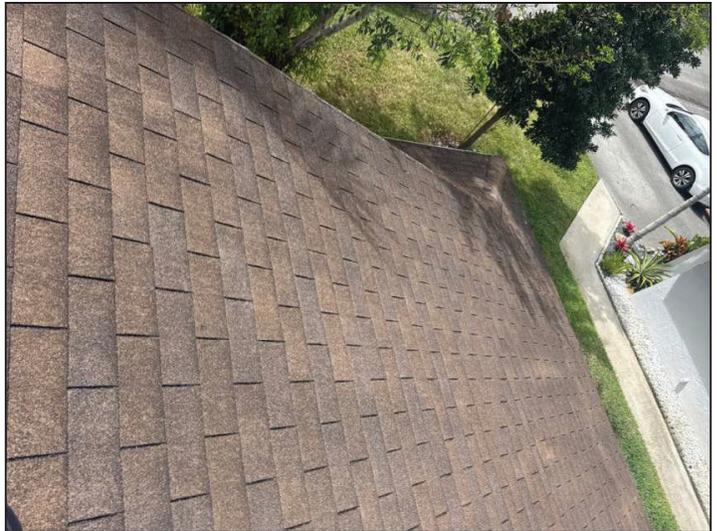
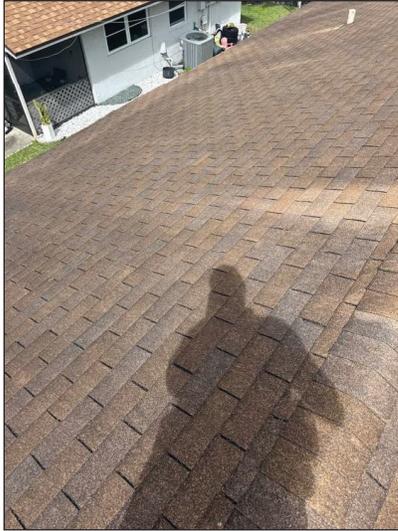
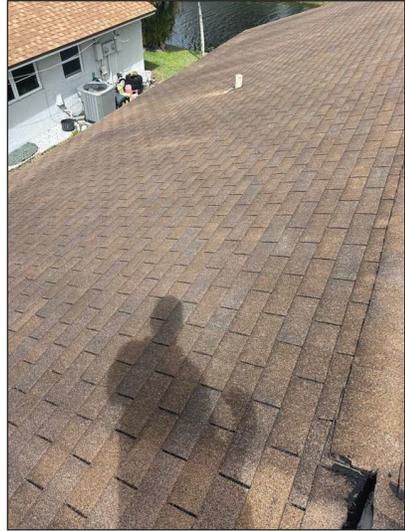
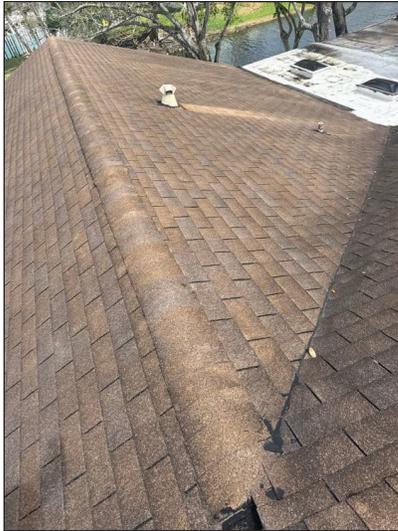
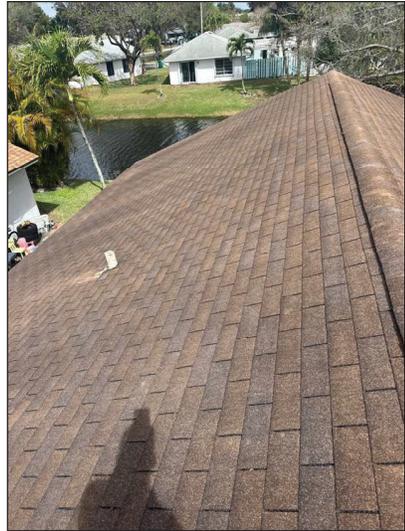
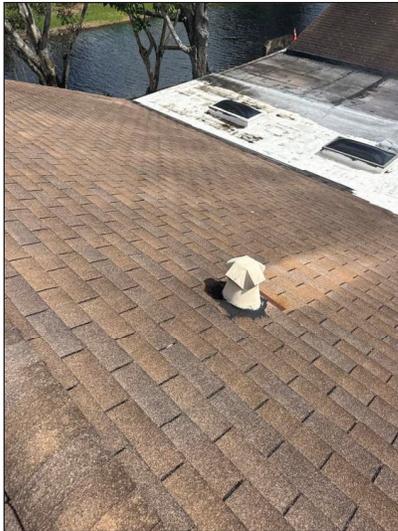
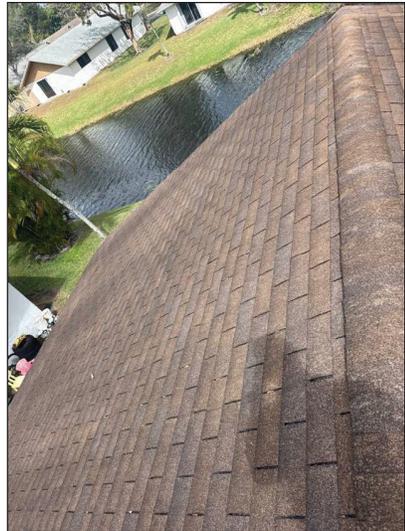
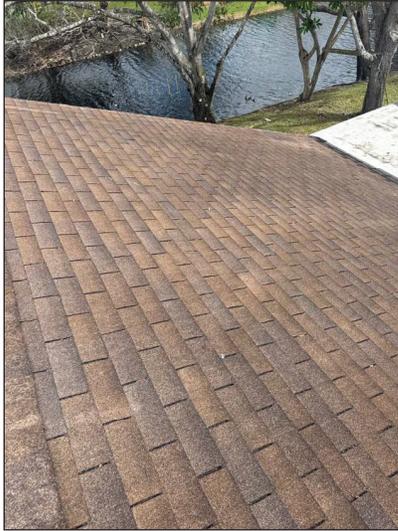
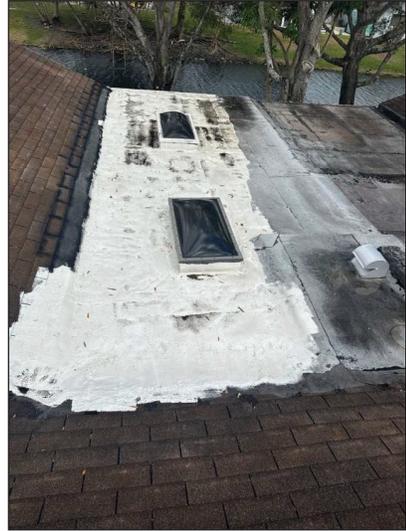
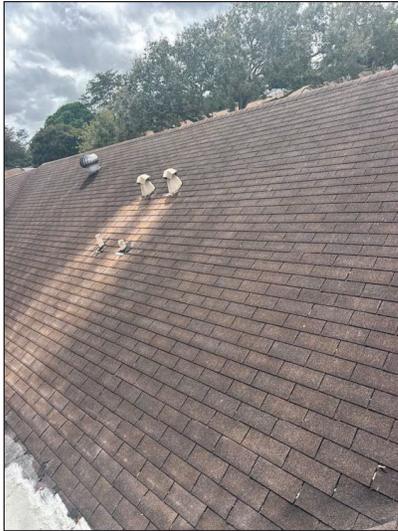
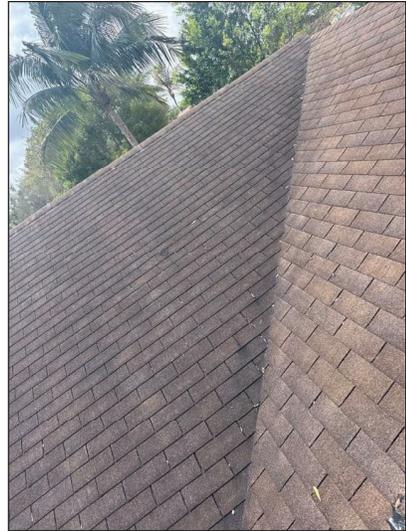
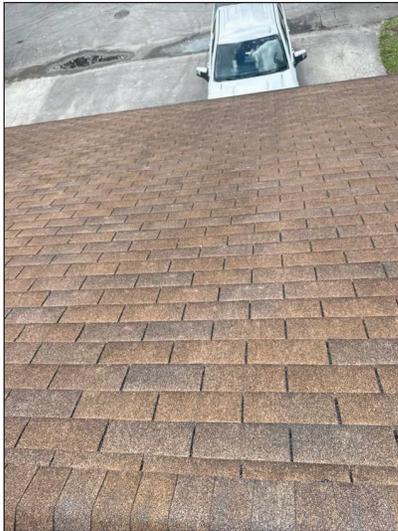
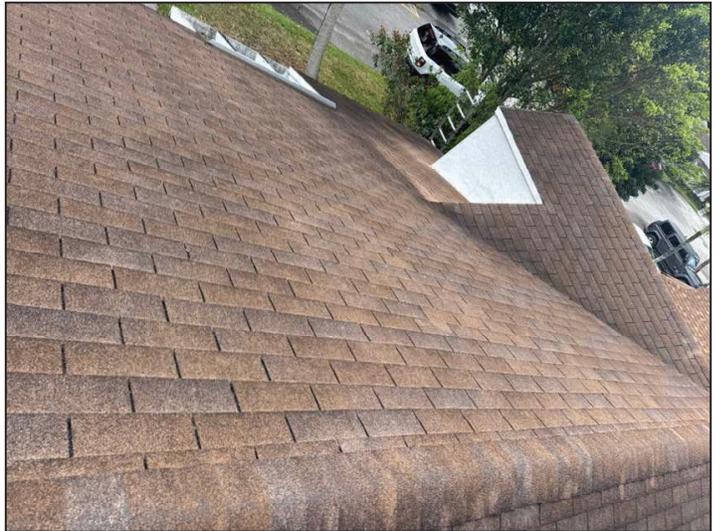
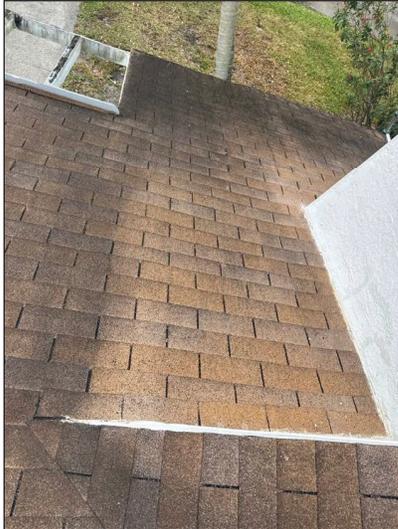
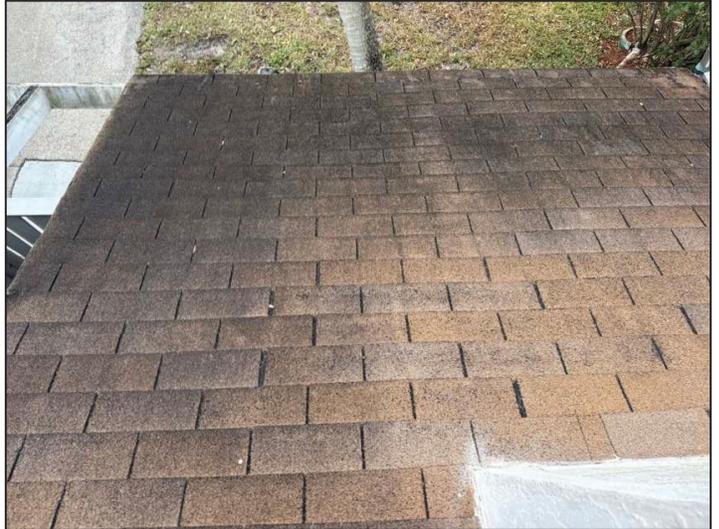
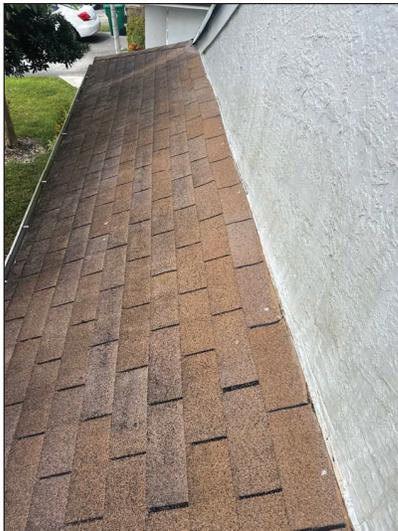
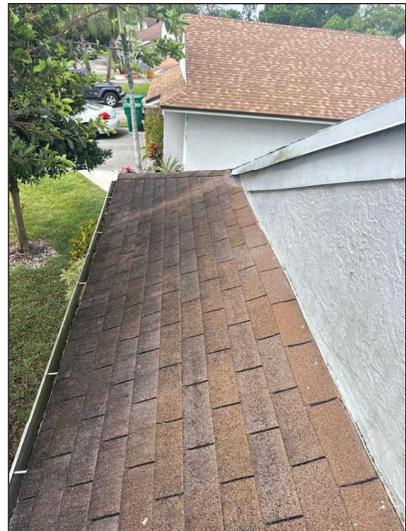
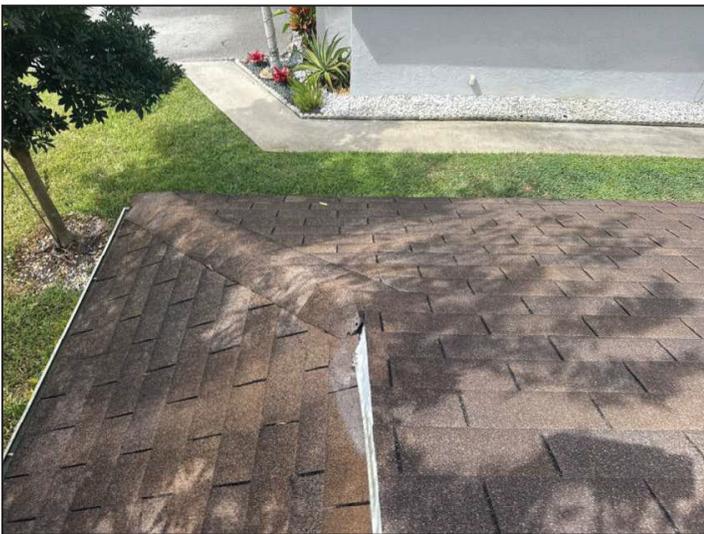
1. Roof Condition

- NOTE: Sellers Realtor states that roof is the HOA responsibility.
- Last re-roof dated as 7/27/07 making it 19 yrs old. Roof has approx 3 yrs +/- life remaining. Buyer is advised that insurance can impose a re-roof sooner if they deem it necessary. Realtor stated that there is an assessment on the roof. Buyer should check status of assessment.

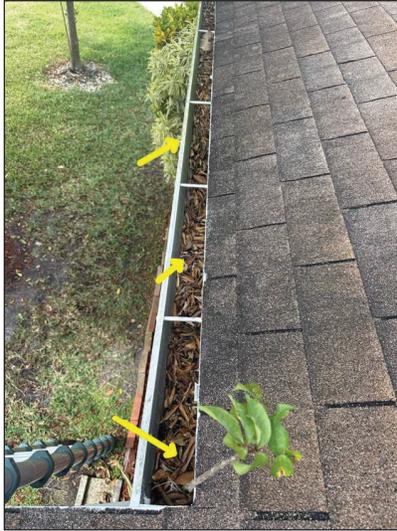
- Clean gutters: Significant amounts of debris evident.

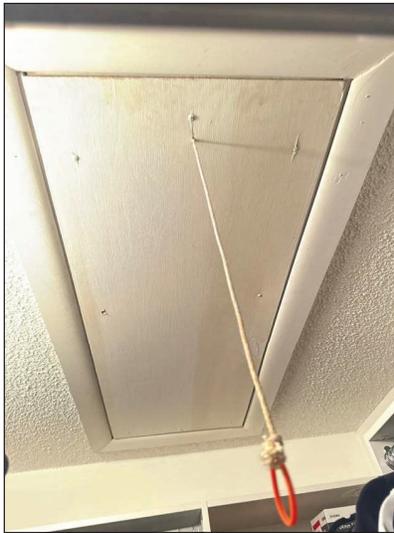
- Pull Down Ladder located master bedroom closet is broken and missing screws. Repairs needed for safe operation.

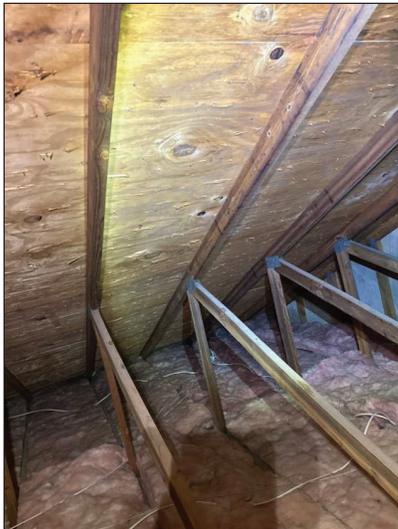
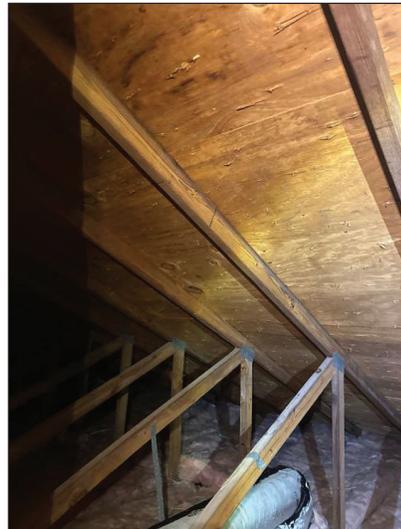
2. Structure

- Could not access all areas of the attic due to limited space.

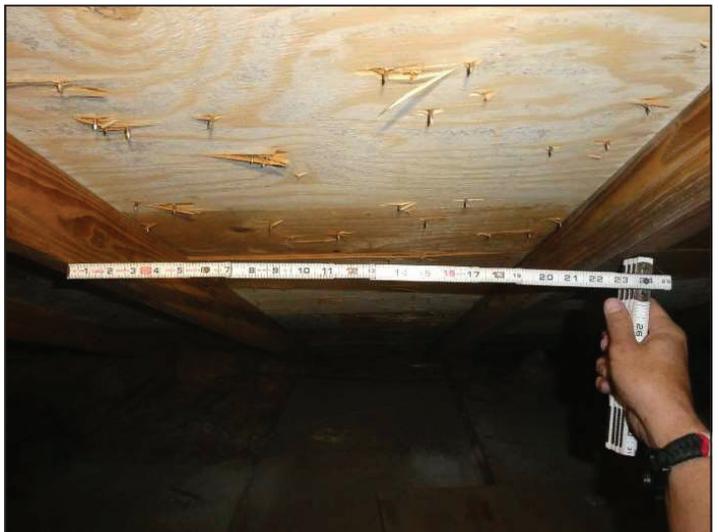
24 INCHES ON CENTER

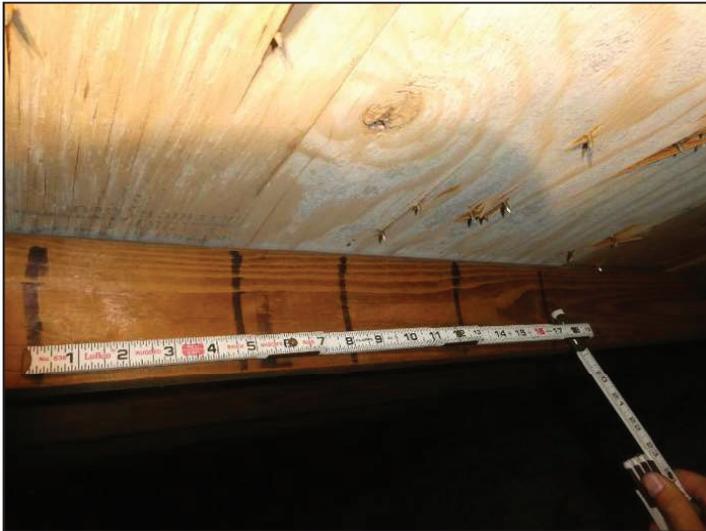
NAIL EVERY 6 INCHES

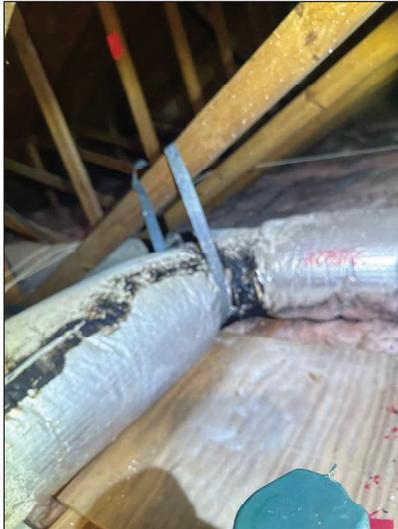
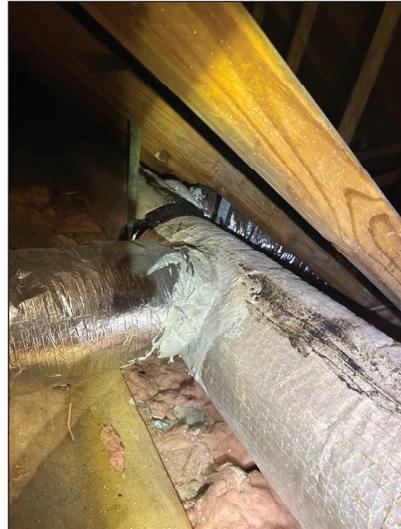
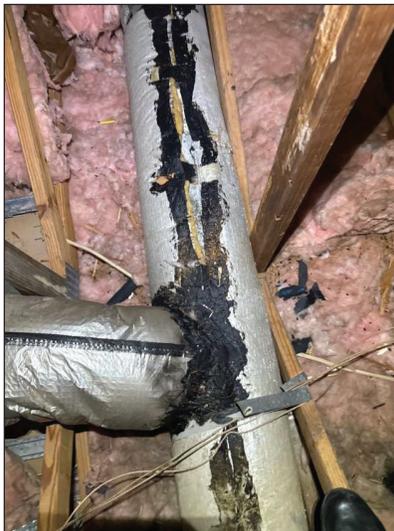
- Old duct work present. Common for a home this age.

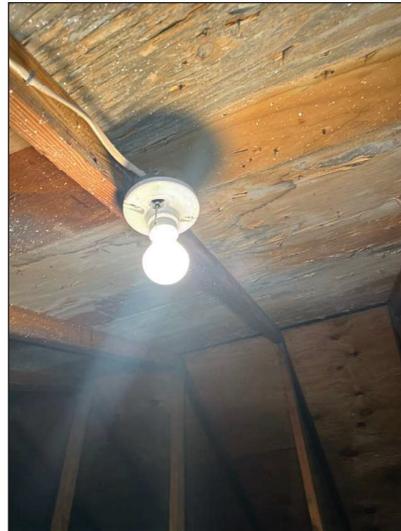
4. Electrical

- Open junction boxes were observed, which is a safety concern. Recommend installing proper covers, as needed, for safety.

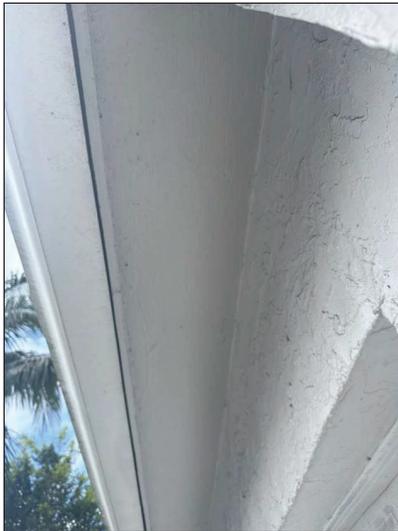
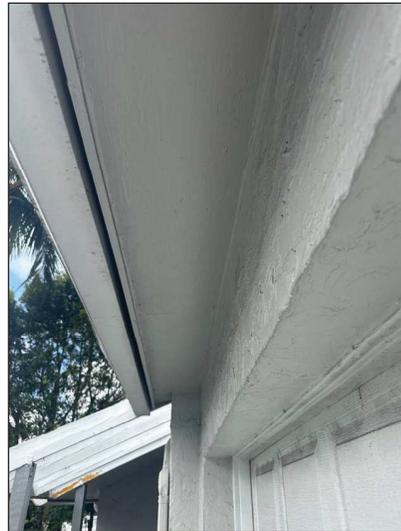
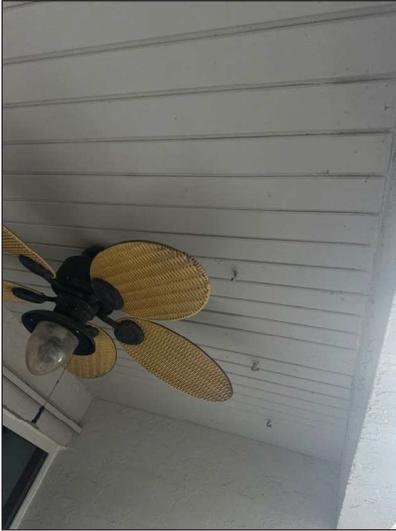
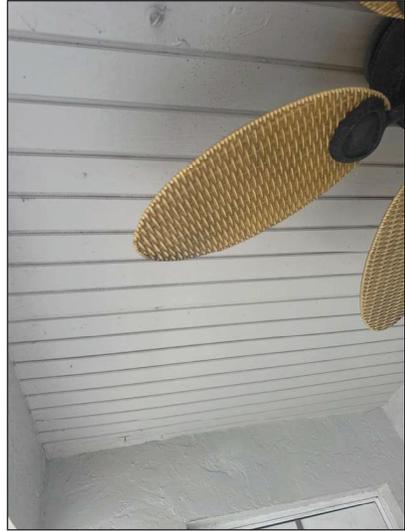
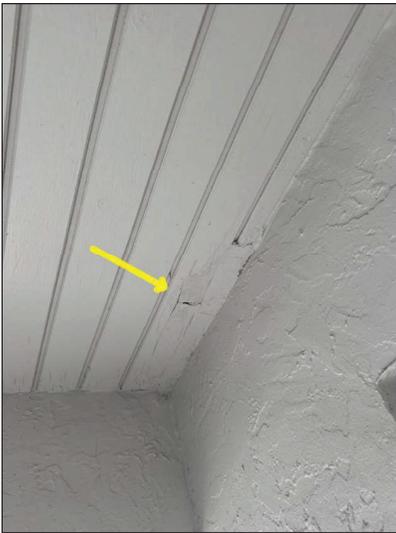
3. Eaves Soffits & Facia

- Suggest sealing/caulking as part of routine maintenance.
- **Moisture damage, wood rot, observed. Recommend review of all areas for repair as necessary. Est cost \$700+**

Moisture damage

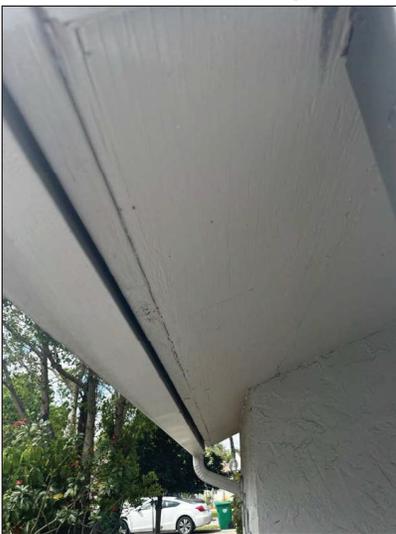
Wood rot noted

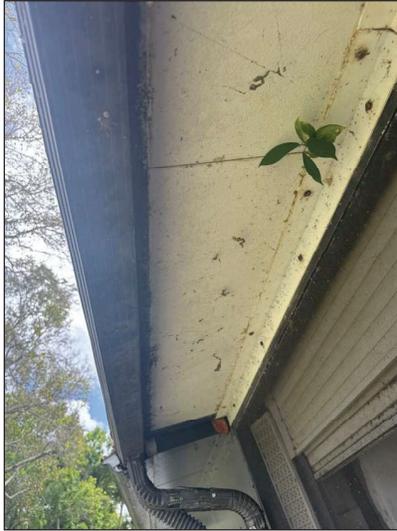
Wood rot

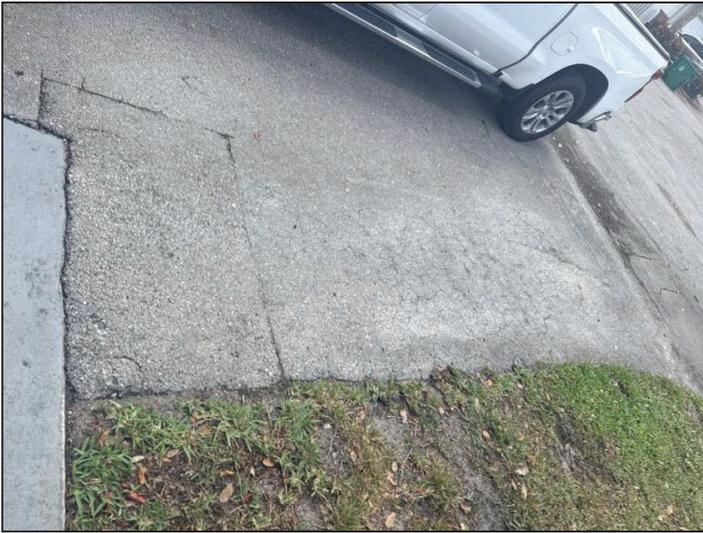
- Driveway in good shape. Recommend sealing to extend life.

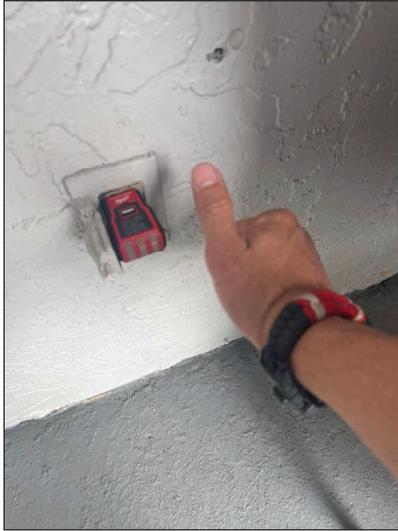
- Reverse polarity noted at outlet. Est cost to repair all electrical issues noted throughout the report to include changing exterior panel \$1,750+

Reverse polarity

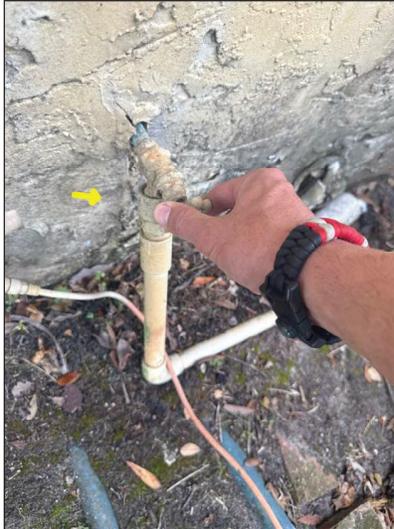
- Spigot on left side of home was not operational. Loose pipe noted. Have plumber evaluate and repair.

Loose not operational

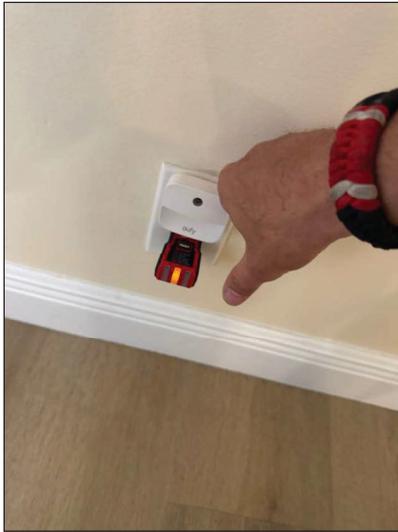
- Outlet to the left and right of window have issues. Have an electrician evaluate and repair.

Open ground

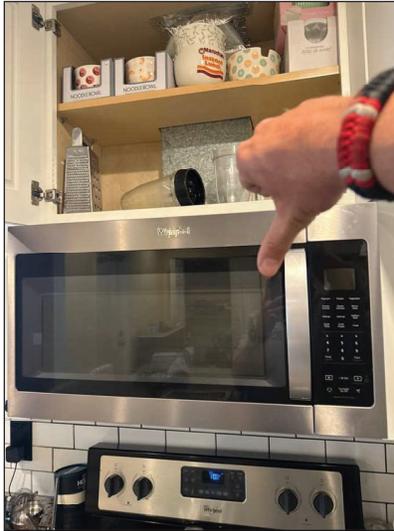
- Not operational at time of inspection. Replacement needed.

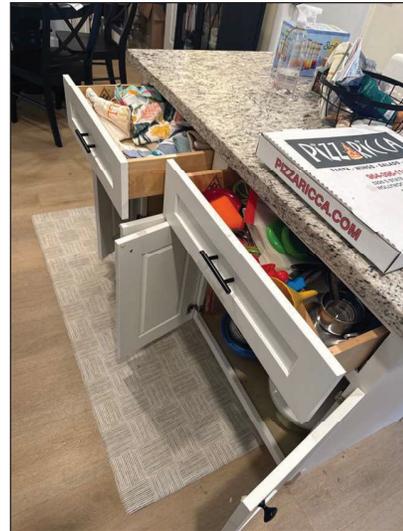
- Appeared functional and in satisfactory condition, For the age of the kitchen time of inspection. Common Cosmetic damages noted Note: doors needs adjusting as some rub together

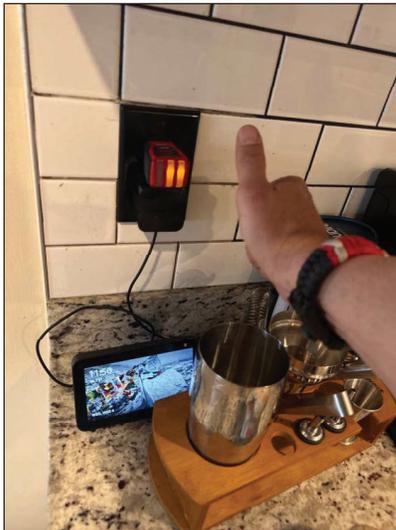
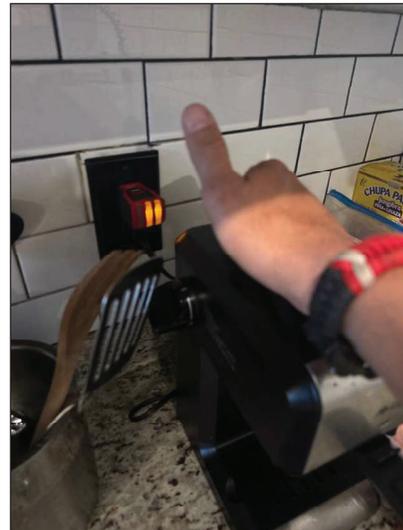
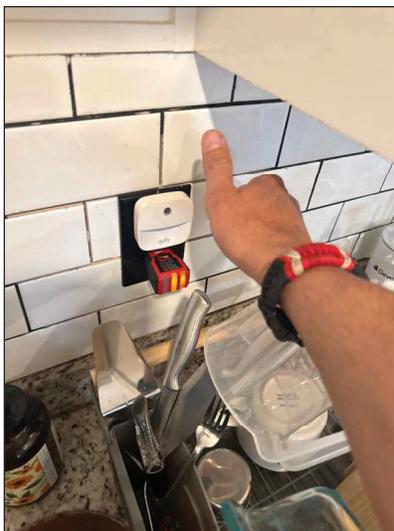
10. Electrical

- Observations:
- No major system safety or function concerns noted at time of inspection.

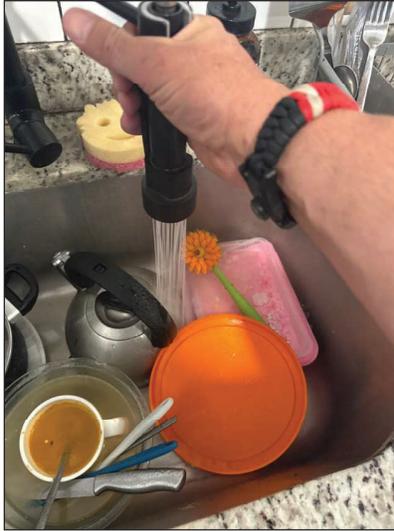
13. Spray Wand

- The spray wand was operated and was functional.

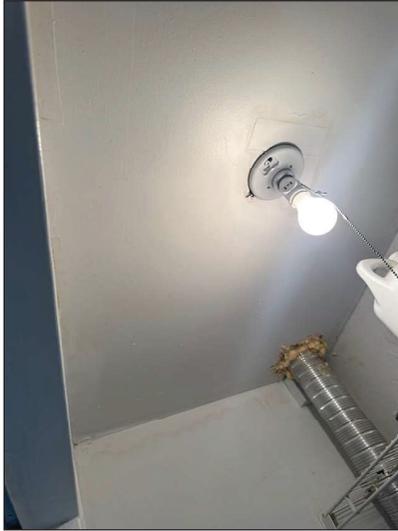
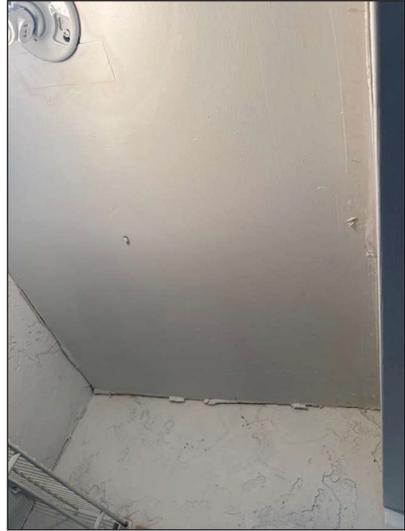
2. Ceiling Condition

Materials: There are wood plank ceilings noted.

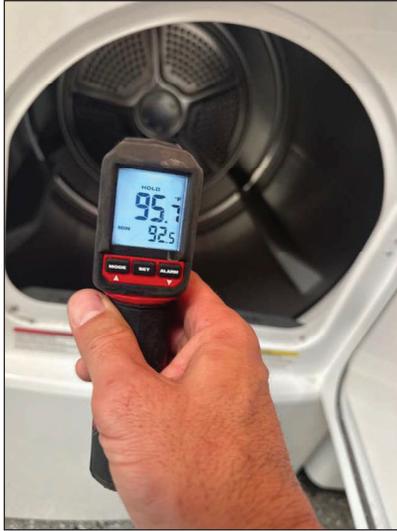
8. Dryer

- Operational at time of inspection. But older unit is noted No warranty is given and units may break down unexpectedly.

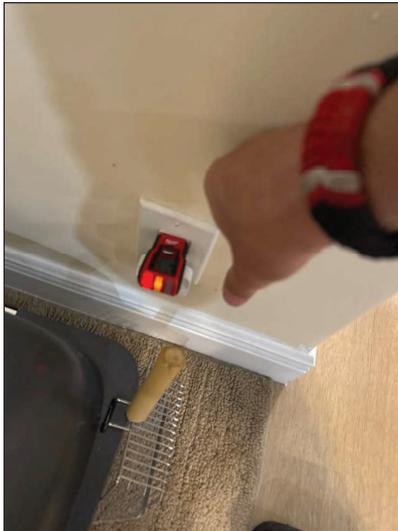
- Outlet to the right of exit door and to the right of bed have reverse polarity have Electrician evaluate and repair

Reverse polarity

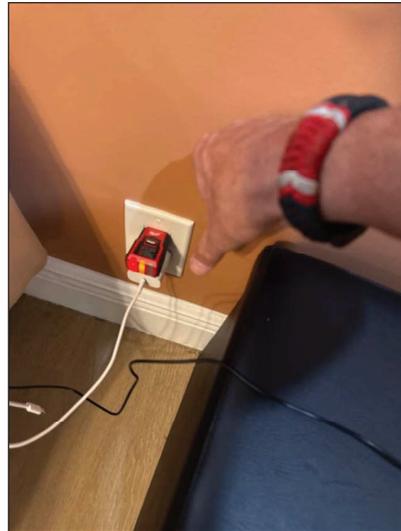
Reverse polarity

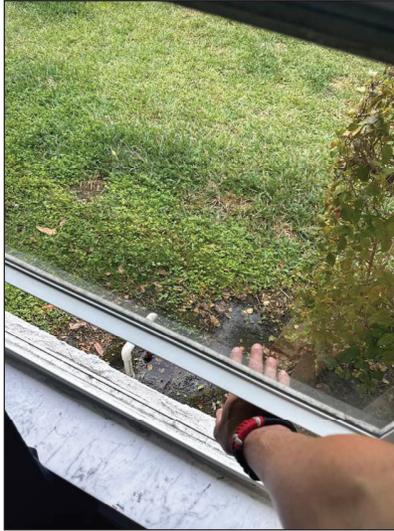
- Missing screen

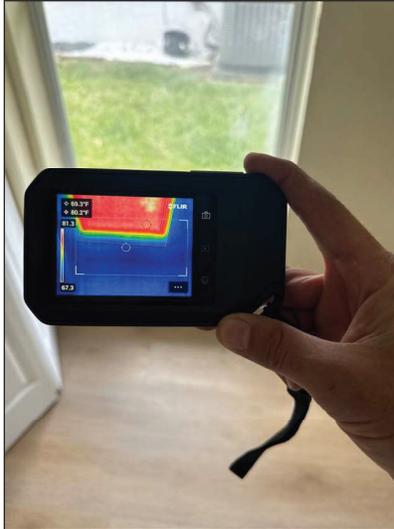
- Cosmetic issues noted underneath window area. Tested dry at time of inspection.

DRY

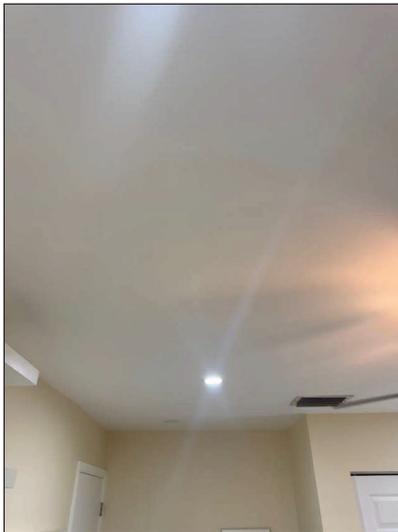
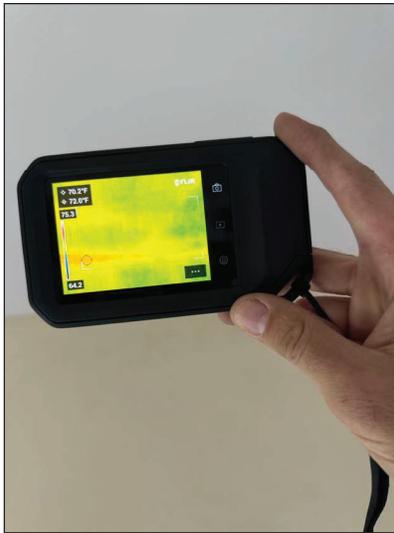
- Cosmetic issues noted at ceiling area. Tested dry at time of inspection.

DRY

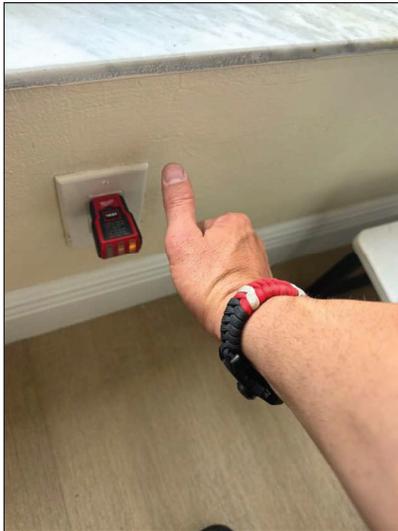
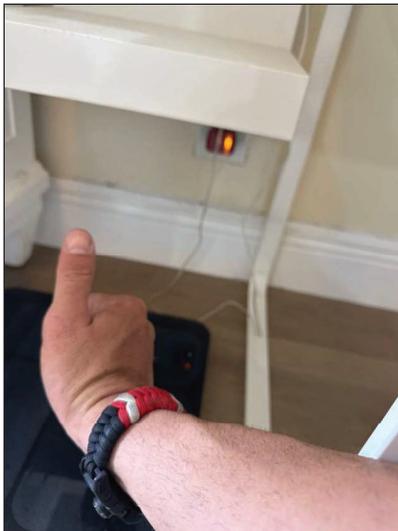
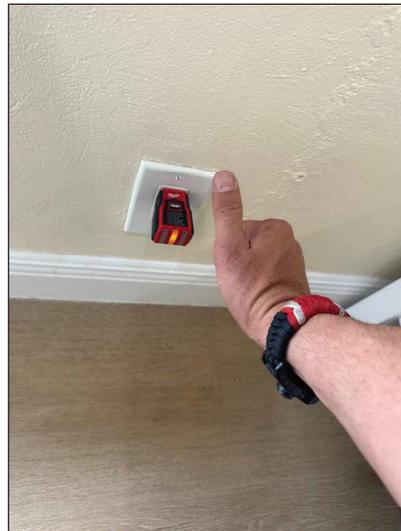
Reverse polarity

- Outlet underneath window facing lake has reverse polarity. Have Electrician evaluate repair.

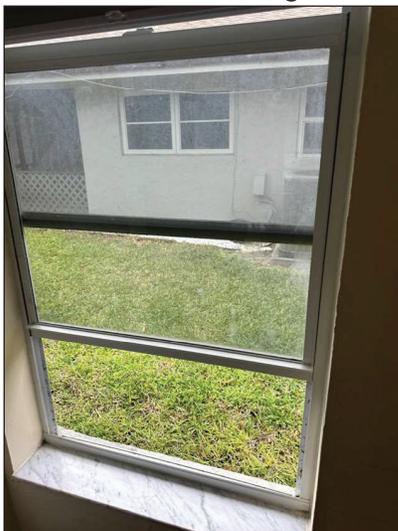
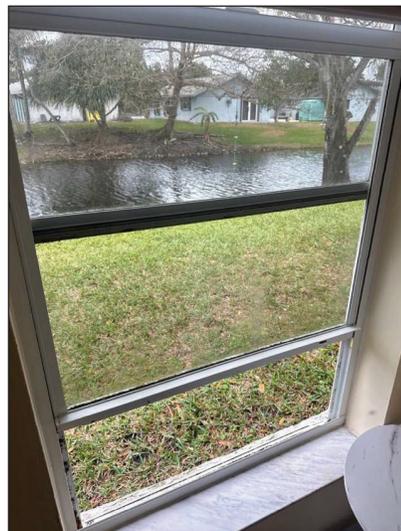
- Observations:
- Missing screens

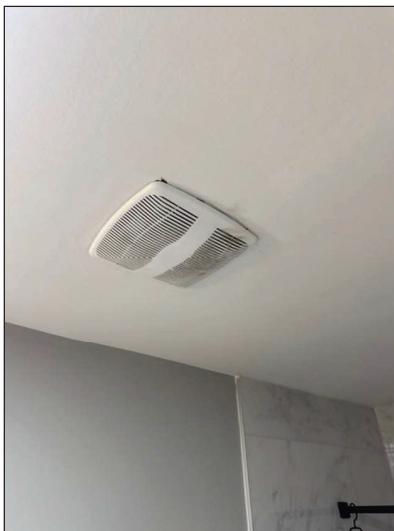
- The bath fan is a worn unit which may be at the end of its useful life.

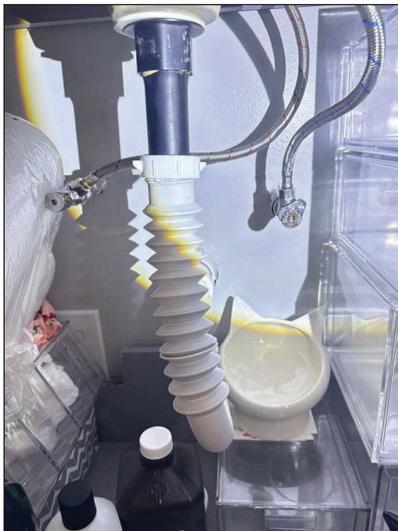
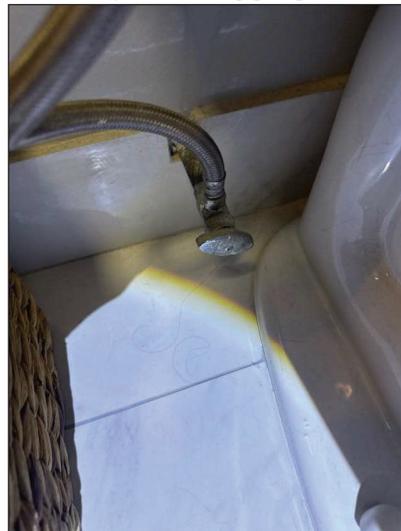
- Flex drain observed, these are subject to frequent clogging.

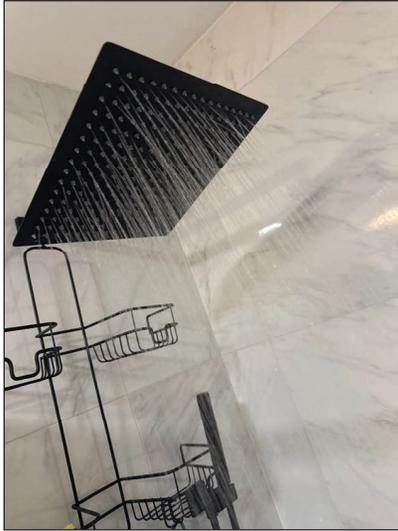
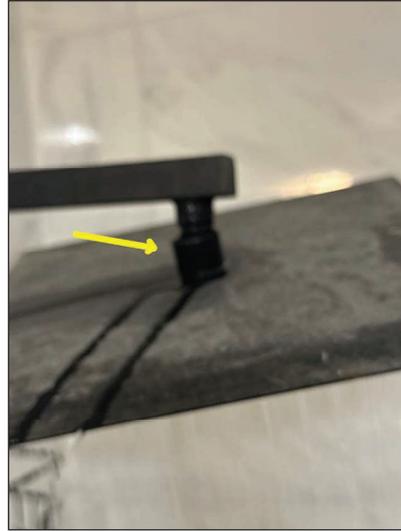
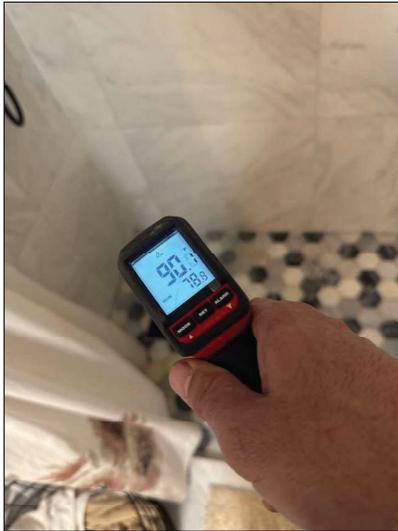
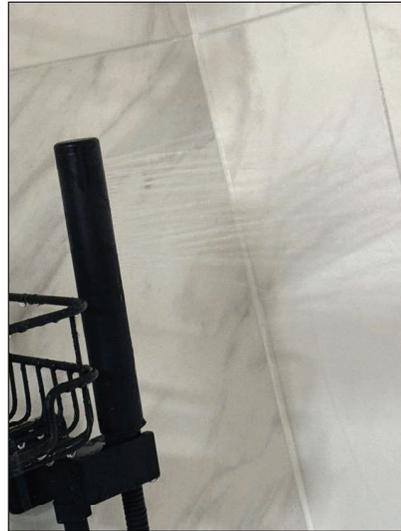
- Leak noted at base of showerhead have plumber evaluate and repair

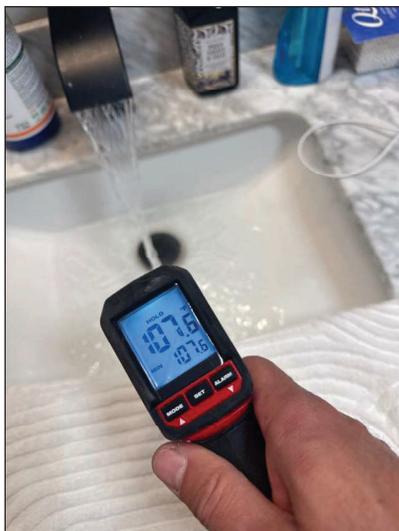
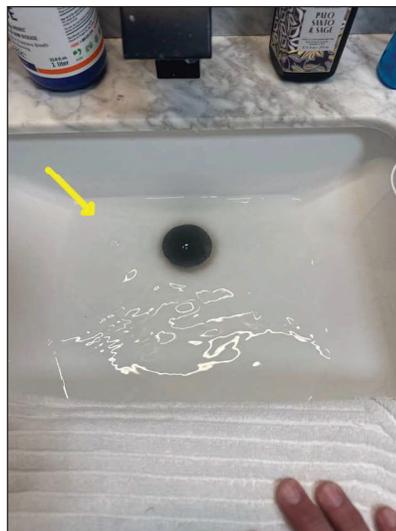
- ****SUPPLY****
- Operated normally, at time of inspection.
- ****DRAINS****
- **Slow drain at sink. Recommend clearing.**

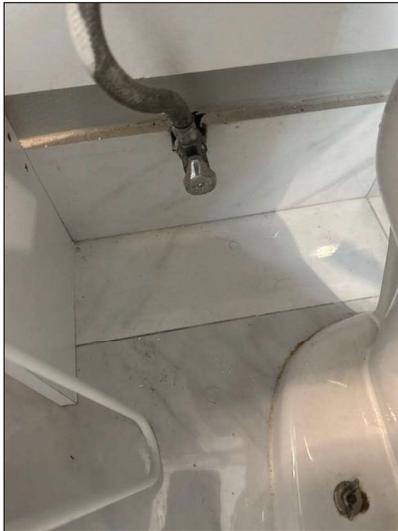
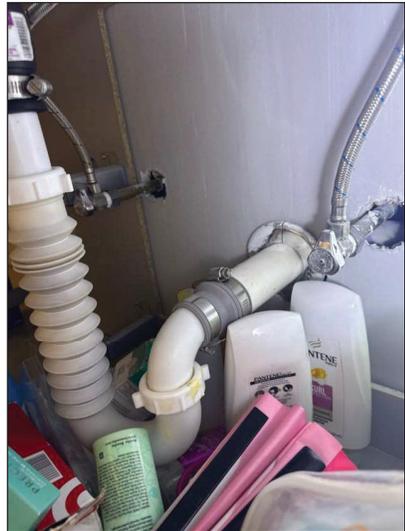
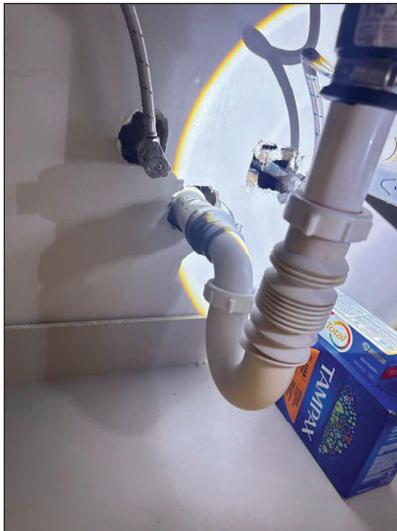
8. Plumbing

- Flex drain observed, these are subject to frequent clogging.

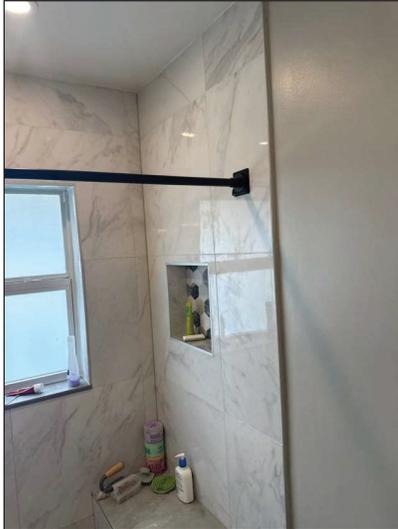
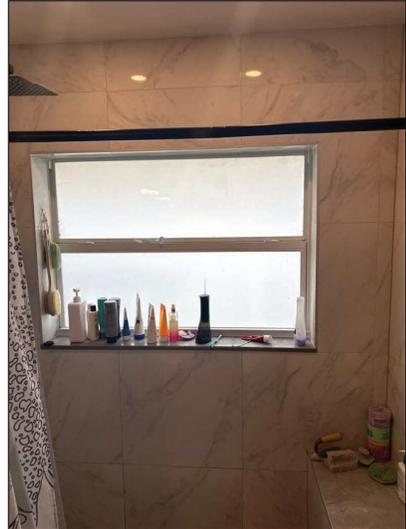
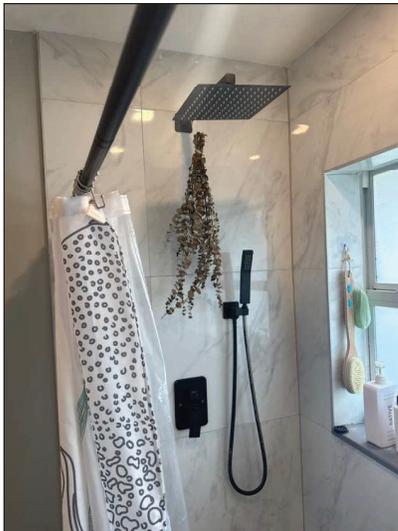
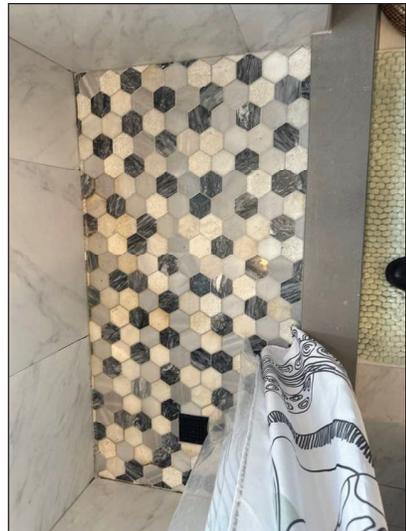
10. Shower Walls

Observations:
• ****MATERIALS****
• Ceramic tile noted.
• ****OBSERVATIONS****
• Caulking needed around perimeter.

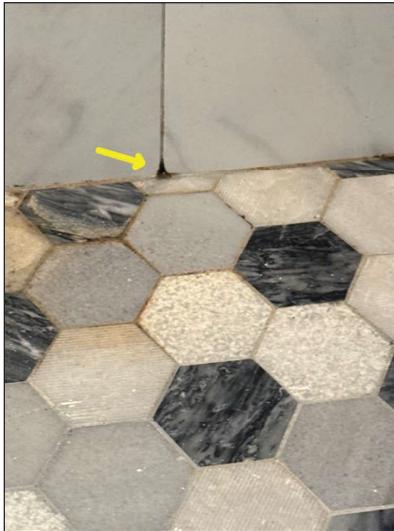
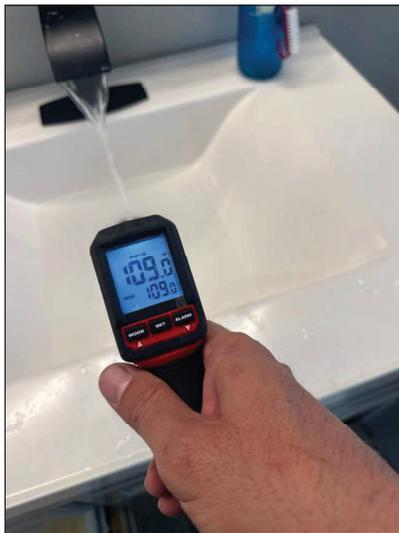
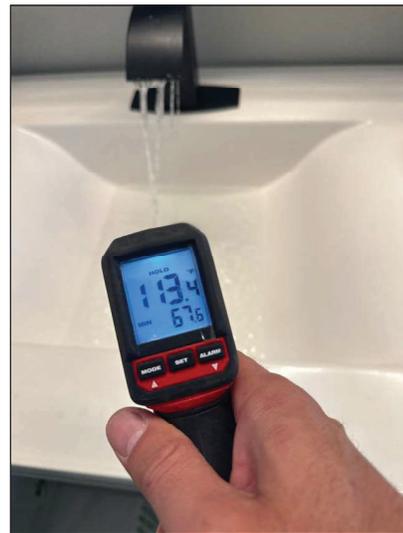
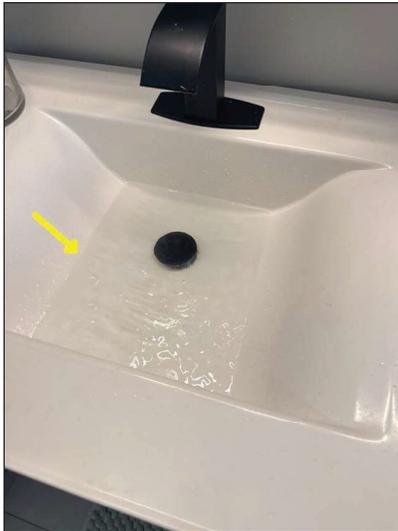
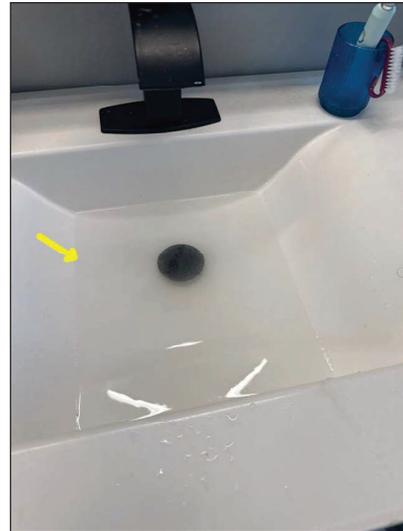
✓				11. Sinks
--	---	--	--	--	-----------

- ****SUPPLY****
- No deficiencies observed.
- ****DRAINS****
- **Slow drain at sink. Recommend clearing.**

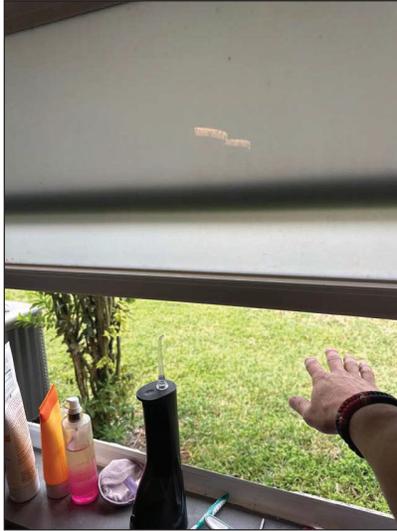
13. Window Condition

- Missing screen

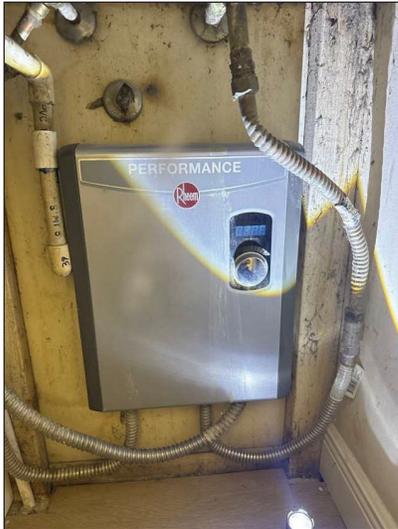
2019

- No major system safety or function concerns noted at time of inspection.

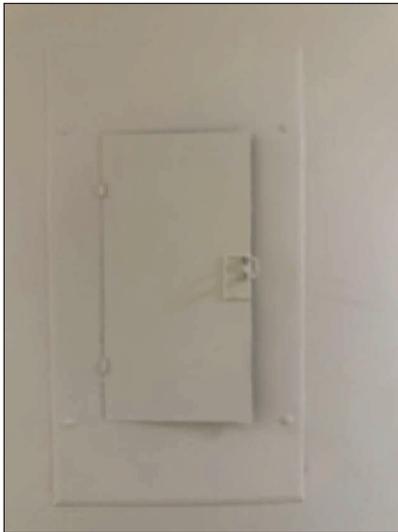
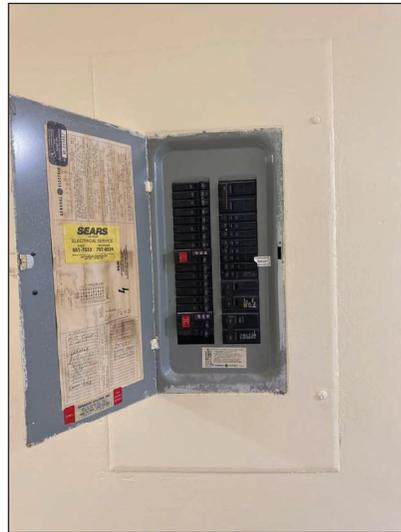
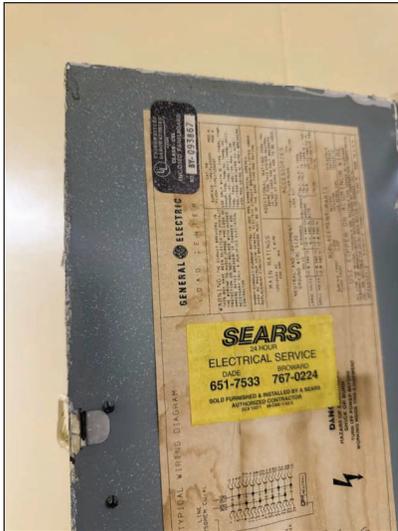
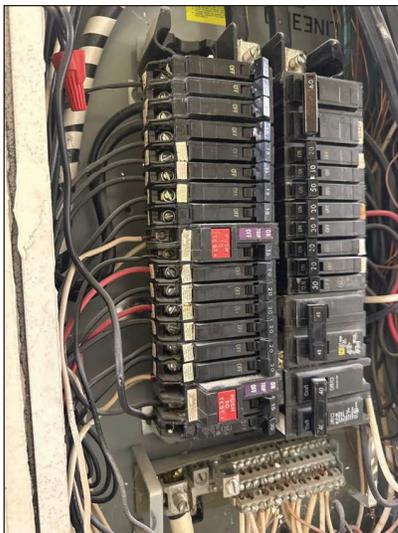
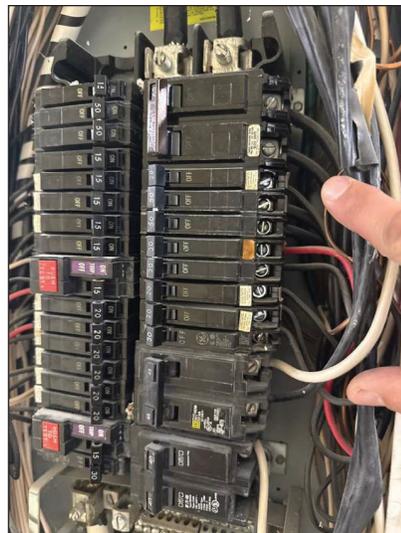
• There is a Sylvania main service panel present. Sylvania components are prone to problems that can lead to failures, lack of proper protection of circuits and other serious issues, including fire and electrocution. We cannot definitively call this panel defective, but recommend, for your peace of mind, to consult a qualified electrical contractor to get their opinion on this matter.

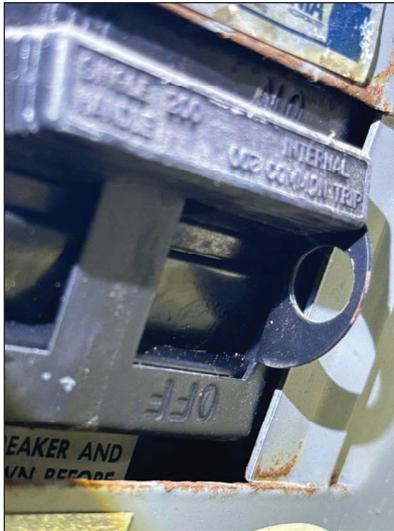
2. Main Amp Breaker

Observations:
• 200 amp

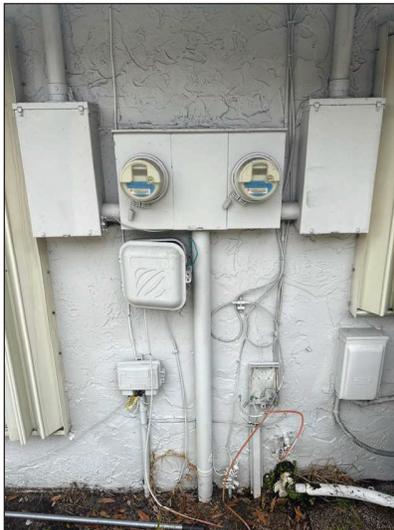
- There is an underground service lateral noted.

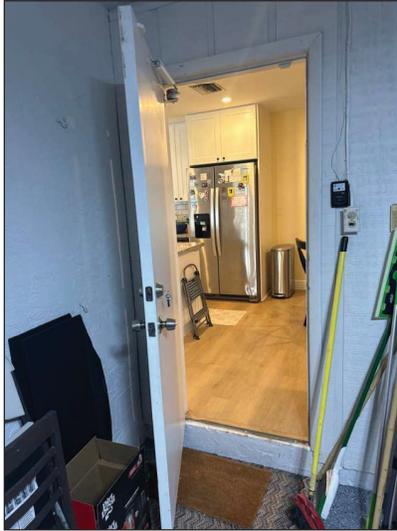
- The automatic closure device does not close the door properly. This could allow a fire to enter the home. Recommend adjusting or replacing the hinges to allow for proper closure of the door.
- Does Not Appear to be a Rated Fire Door

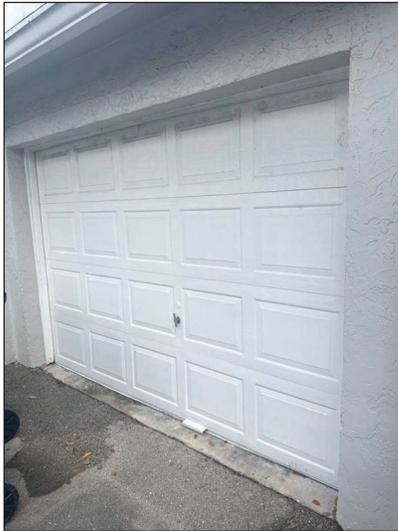
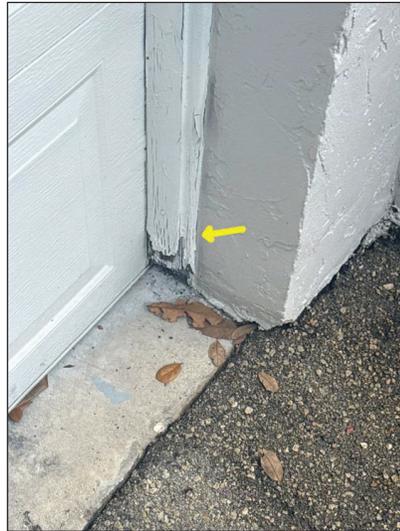
6. Garage Door Condition

- Repairs needed around exterior frame

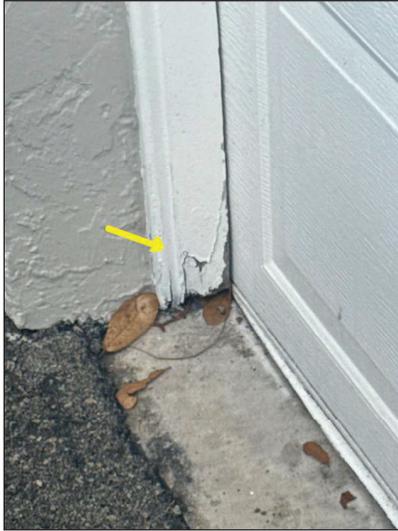
Wood rot noted
