PROPERTY INSPECTION REPORT

George Castillo HI11662
Professional Property Inspectors

Date of Inspection: 3/4/2026
Year Built: 1981/45 Yrs Size: 1825 ft.²
Weather: Clear

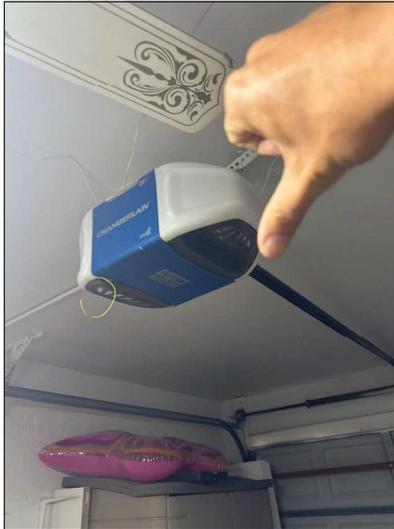
7. Garage Opener Status

- Garage vehicle door opener appears to be damaged or otherwise inoperable. Have evaluated and repaired.
